Engineering Assessment of Flooding at Arroyo Doble Subdivision

Dr. David T Williams, P.E. (TX PE 80003), PhD, PH, DWRE

Dr. Gerald Blackler, P.E., PhD

Date: July 26th, 2018

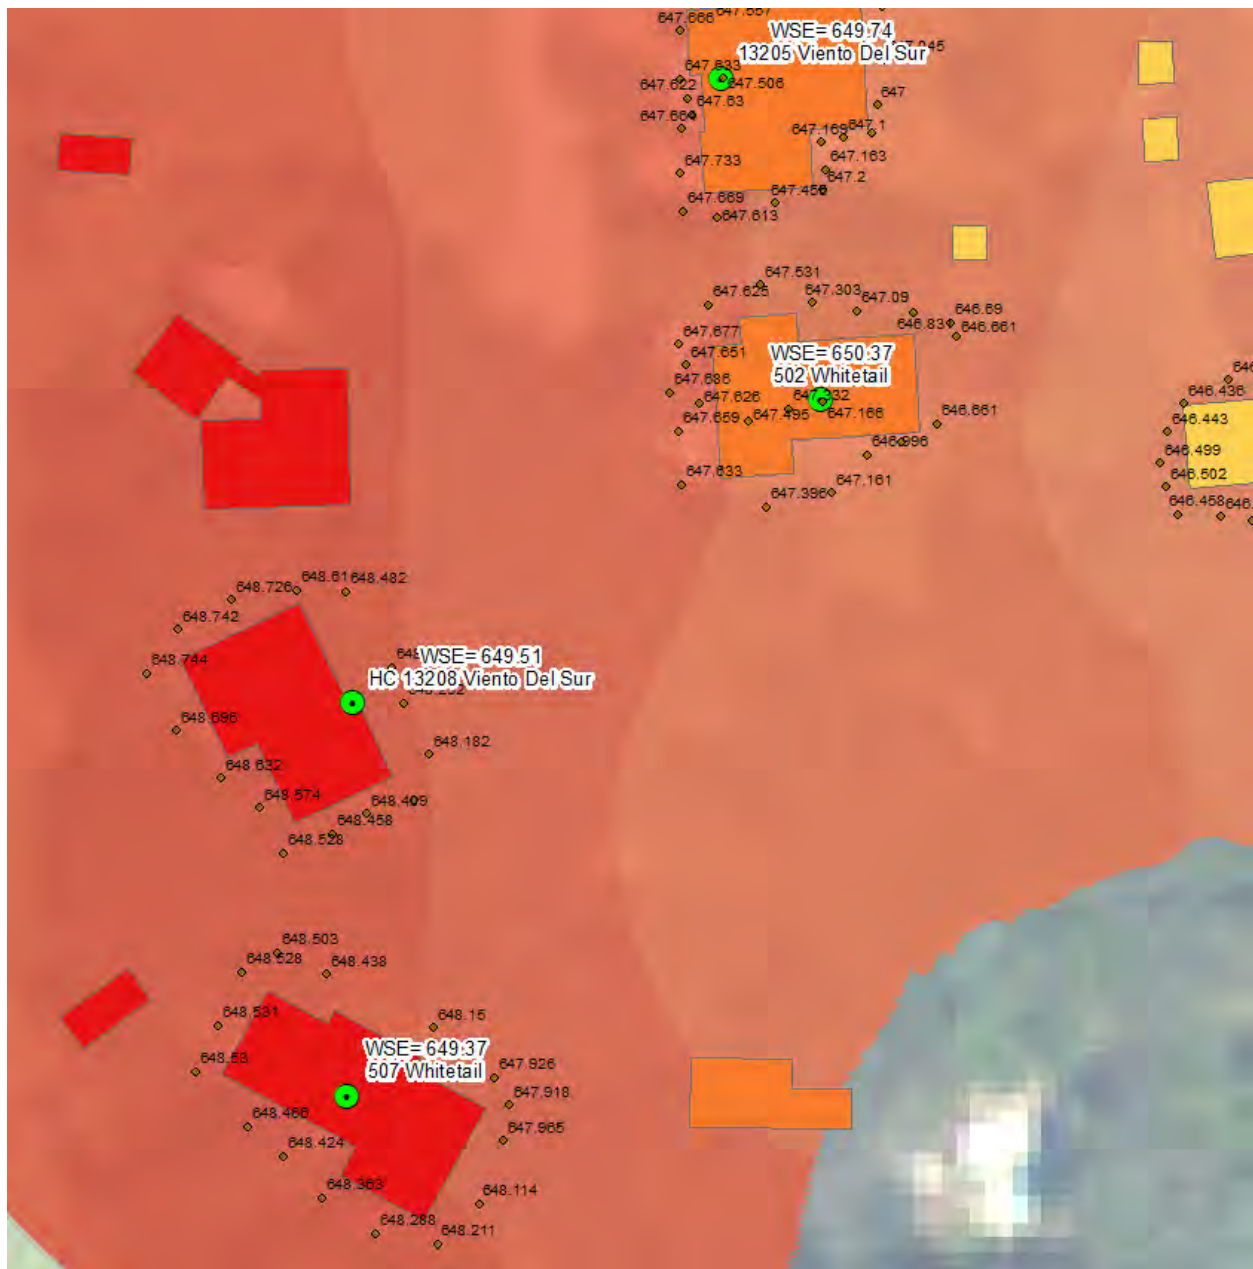
Figure 11 – Image of the WSE Grid and Energy Values Surrounding Structures, showing that the Max Energy is usually the Approach Energy on the Structure that is translated into a Pounding Wave that runs ups the outside of the Structure

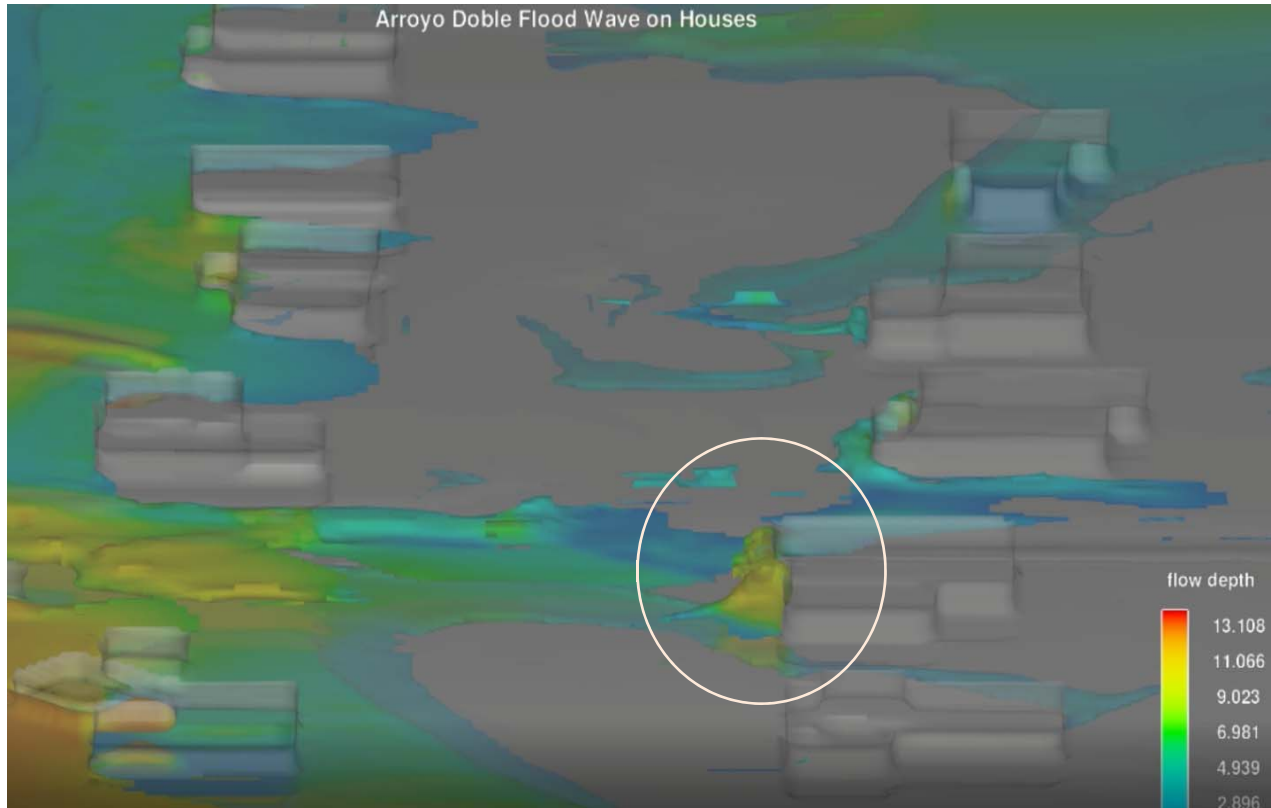
elevation. The hydraulic models' inability to simulate this momentum runup as well as the issues related to the velocity head were the main reasons that the models under-predicted the measured water surface elevations by an average of about 0.5 feet. However, the differences between scenarios are of the most interest so the analyses presented are deemed valid.

Figure 12 - CFD model showing initial wave runup onto structure before the full peak concentrates in the Neighborhood

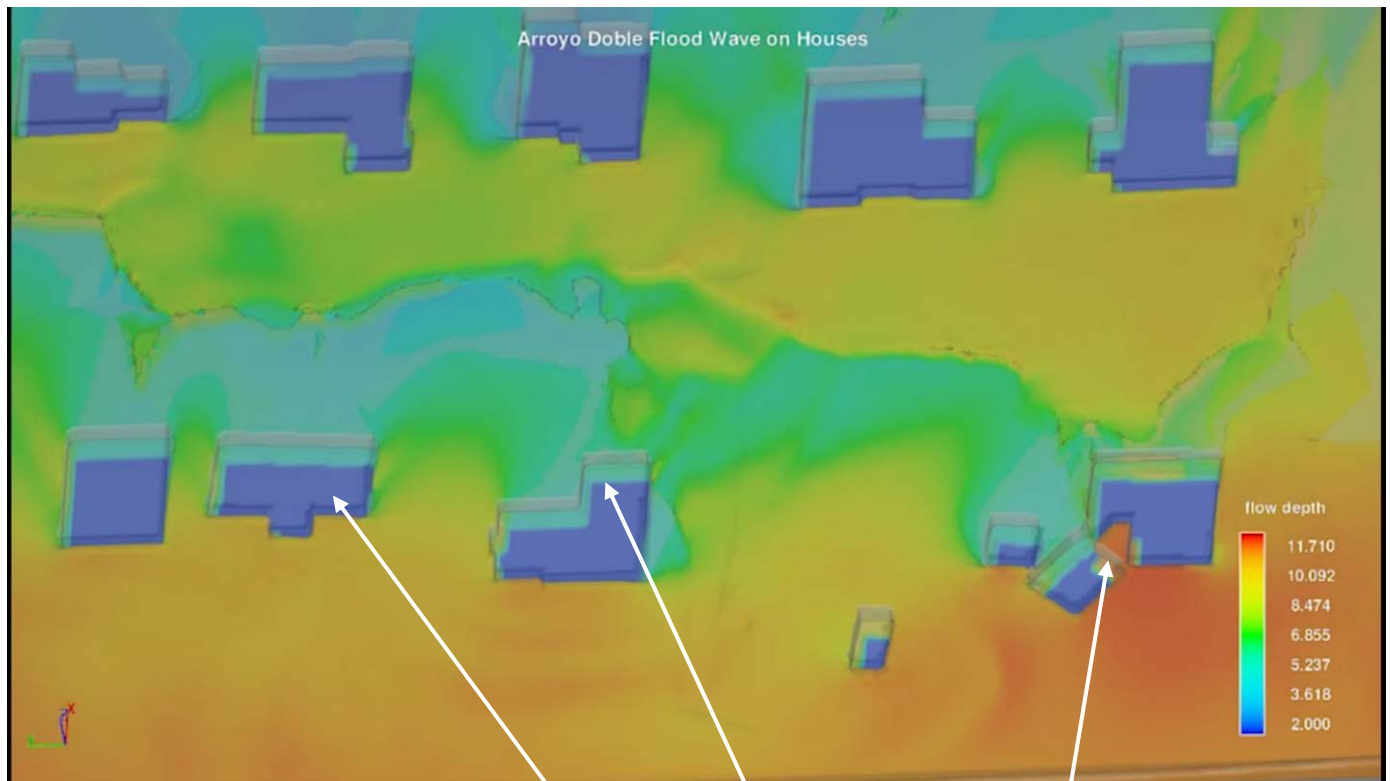
Figure 13 – Depth of Flood Wave Runup on Houses, developed within Flo3D CFD Software. Google earth image presents arrows to houses in model for a reference to location.

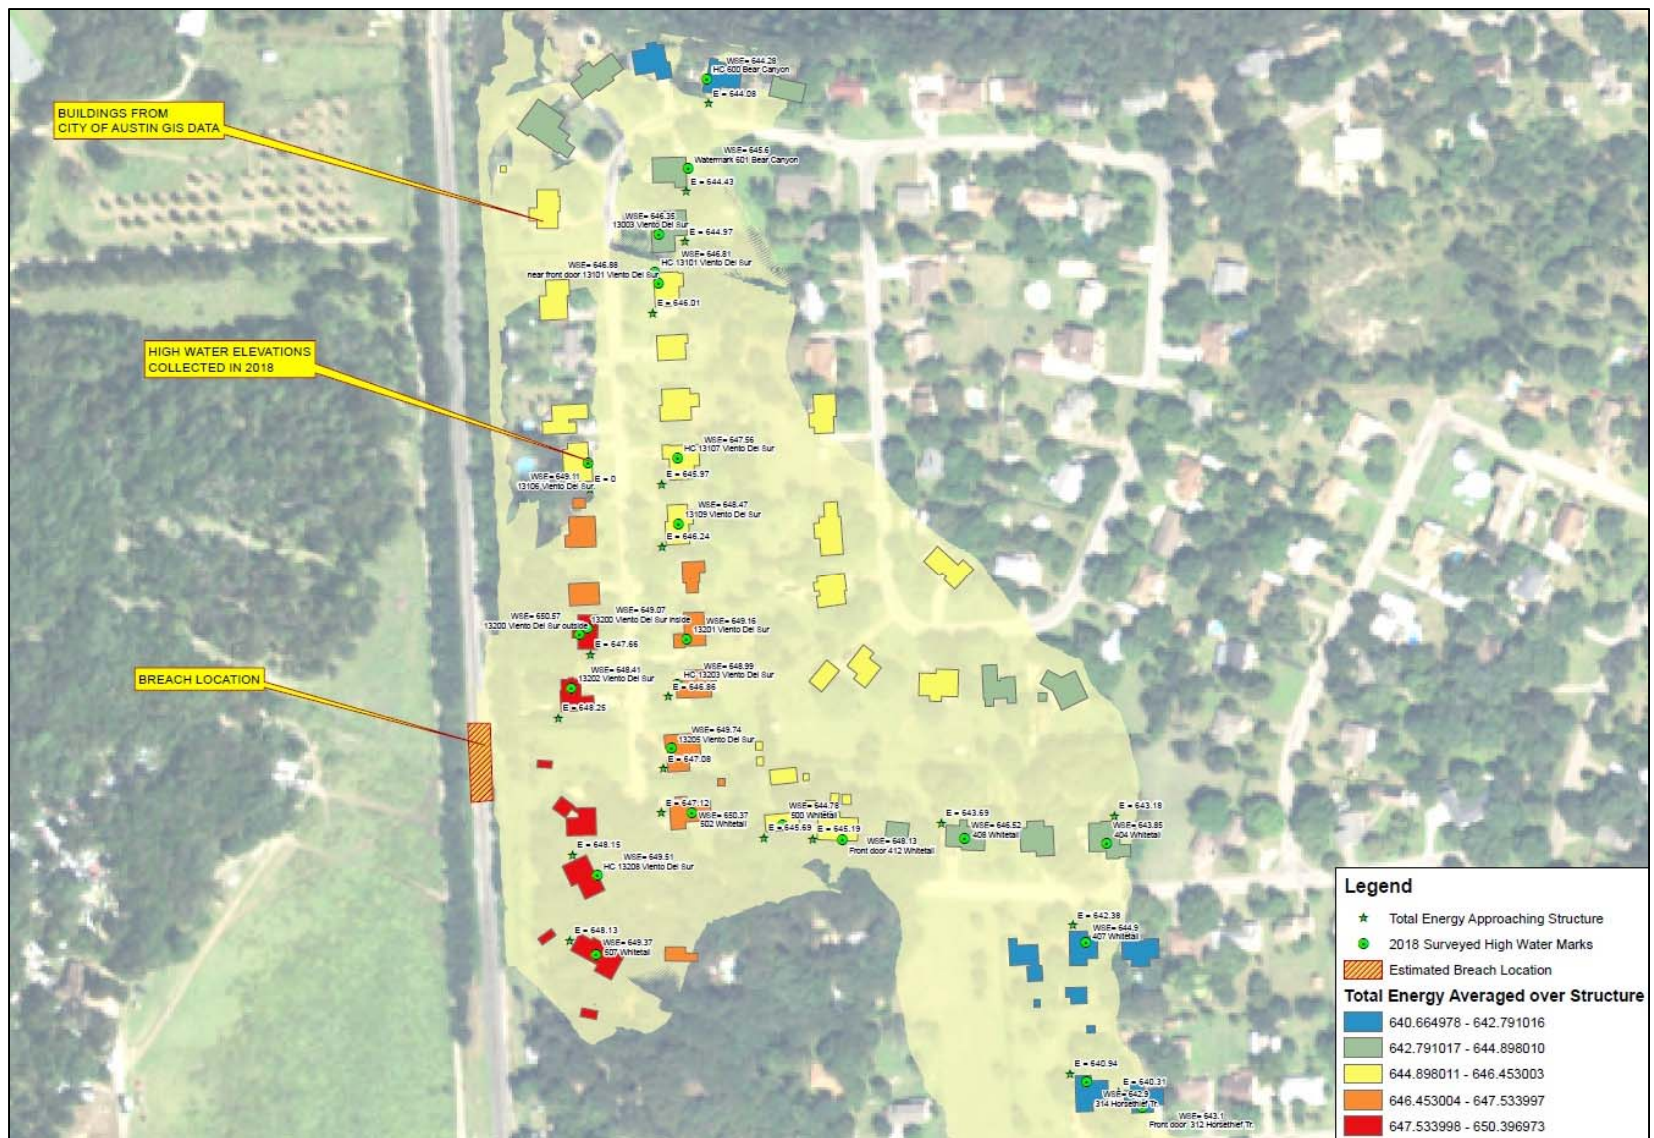
3. For the condition of the railroad embankment in existence and a breach of the embankment, which is the situation that occurred on October 2015, the flooding extent and water depths were greater than if the railroad embankment was not there. In addition, the October 2015 embankment breach resulted in greater flooding extents and water depths than the condition of the existence of the railroad embankment with overtopping and no embankment breach.

Figure 14 – WSE and Energy Estimates from the 2D Unsteady Breach Model ($Q_p=4,637$)

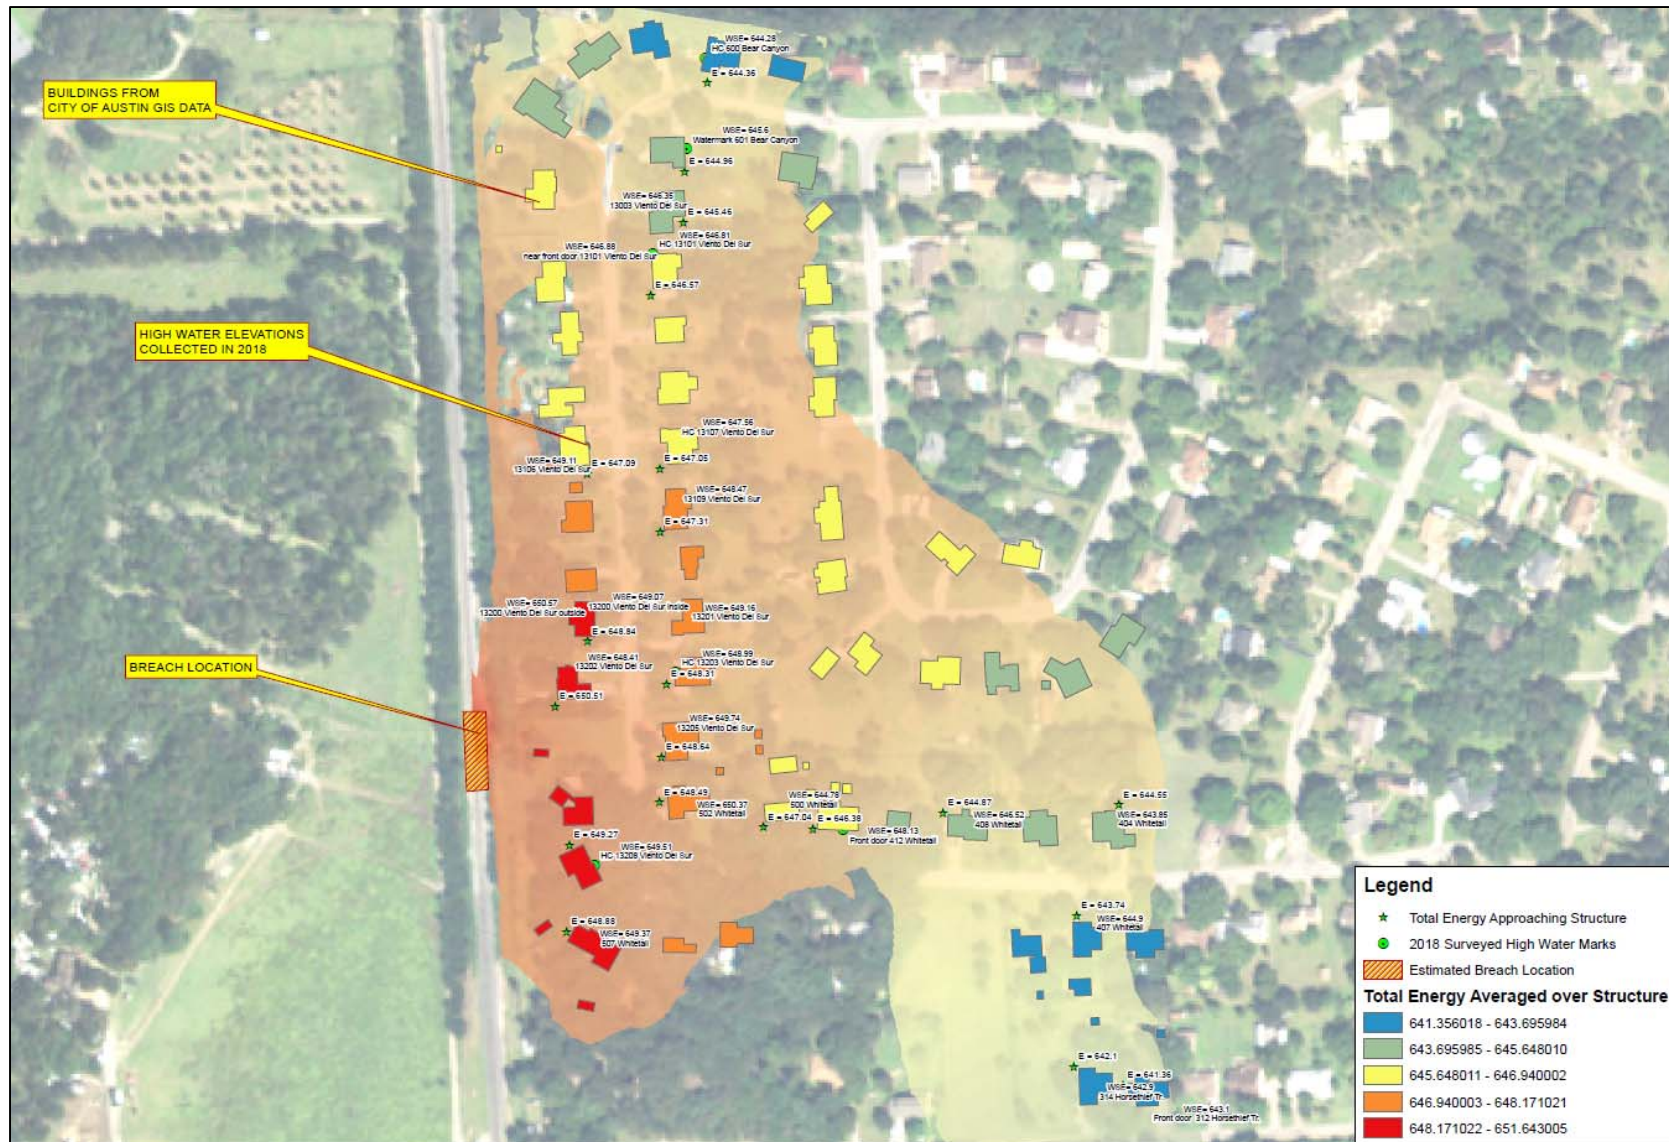
This analysis has found that the embankment failure of the UPRR Railroad embankment in October of 2015 may have produced up to 7,169 cubic feet per second (cfs) of a flood surge that flowed into the Arroyo Doble subdivision. If the embankment had not failed but instead, 1) overtopped and not breached, or 2) if it had a culvert placed to ease the pressure of flow, the maximum released flow for this event would have been between 900 and 1,300 cfs, depending on the storm distribution. Under these two scenarios, the number of houses inundated would have been fewer and the extent of inundated would have been less. Had the UPRR Railroad corrected this drainage deficiency, the amount of damage caused by this failure could have been significantly diminished.

Figure 15 - WSE and Energy Estimates from the 2D Unsteady Breach Model ($Q_p=7,169$)

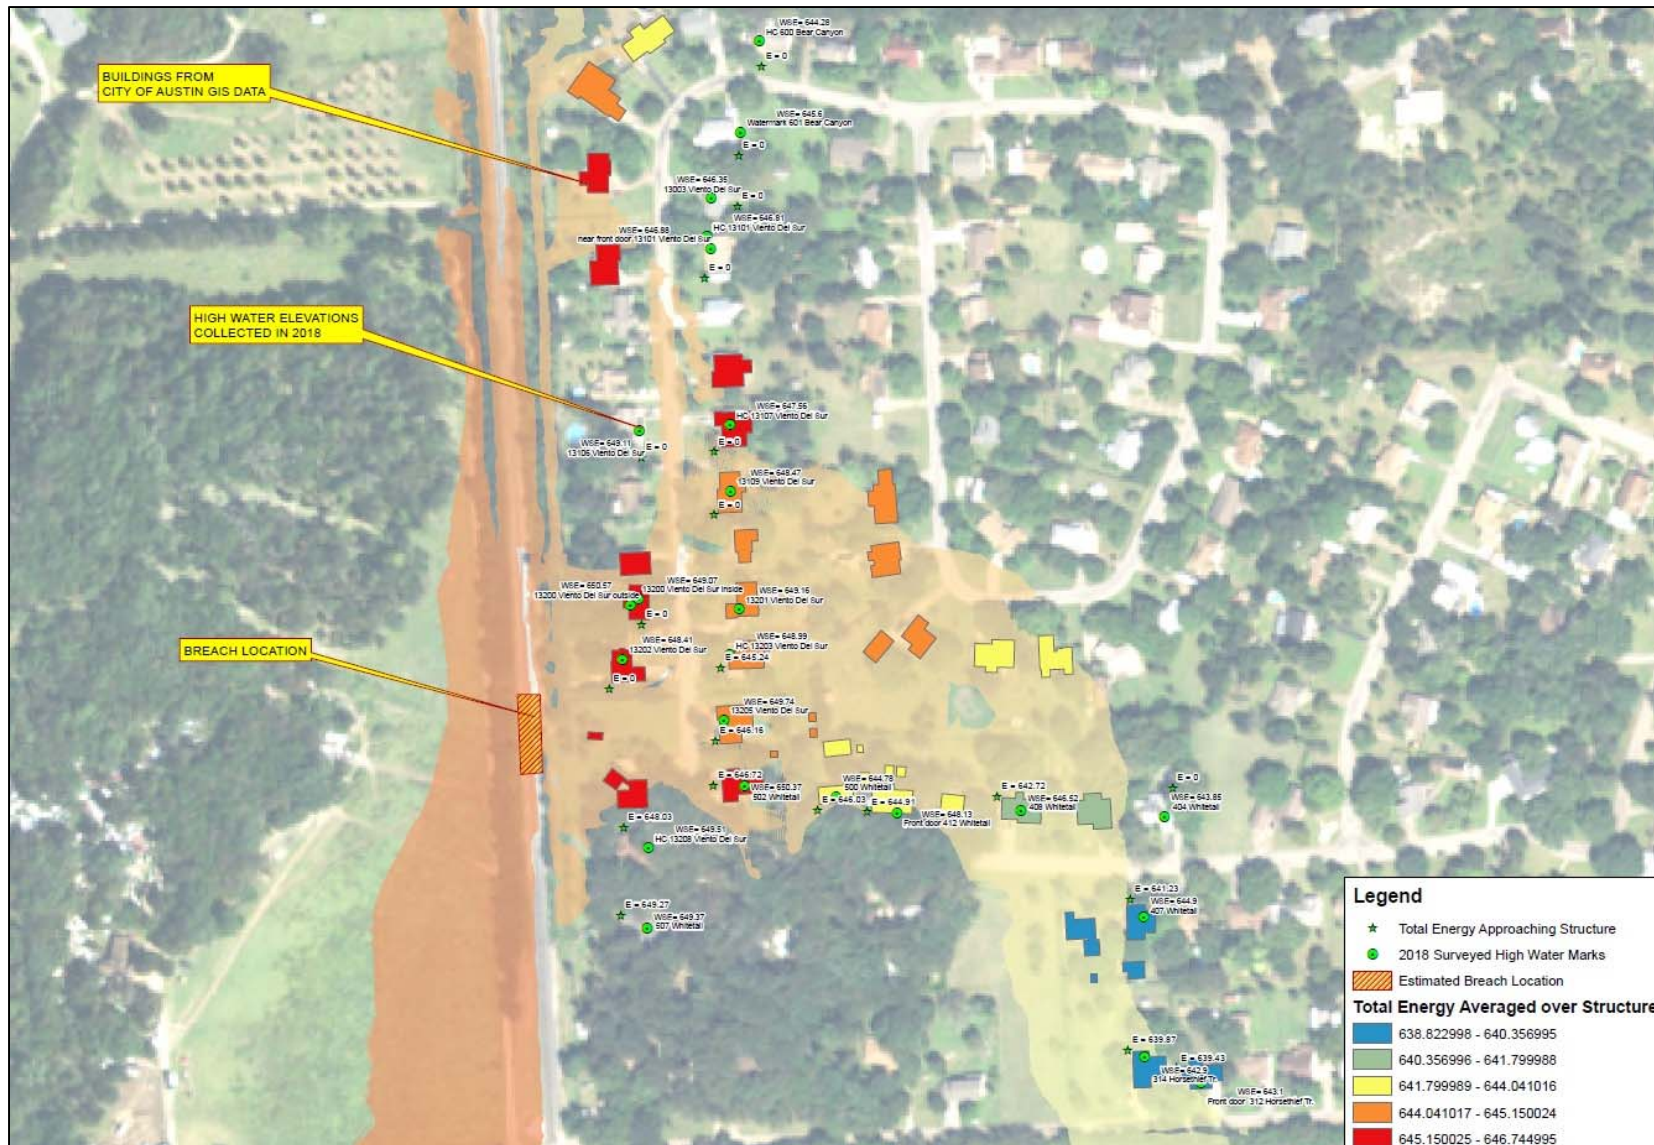
Based on the hydrologic and hydraulic modeling, it is estimated if the embankment would have not failed, but instead simply overtopped and stayed, or had a culvert placed, the maximum released flow for this event would have been equal to or less than the inflow to the UPRR embankment, which was between 900 and 1,300 cfs depending on the storm distribution. This would have been much lower than our predicted peak flow rates of what actually happened in October 2015. The figures below present four maps, the first two are the result of the water surface elevations and total energy on the structures from the breach estimates, the third presents the impact on structures if the embankment did not breach but simply overtopped, and the fourth presents the impact on structures if the railroad embankment did not exist. As shown, the number of houses inundated is fewer and the flooding depth is less for the ones that are inundated. Had the UPRR Railroad corrected this drainage deficiency in the past, the amount of damage caused by this failure could have been greatly diminished.

Figure 16 - WSE and Energy Estimates from the 2D Unsteady Existing Model, which assumes the UPRR Embankment does NOT Fail

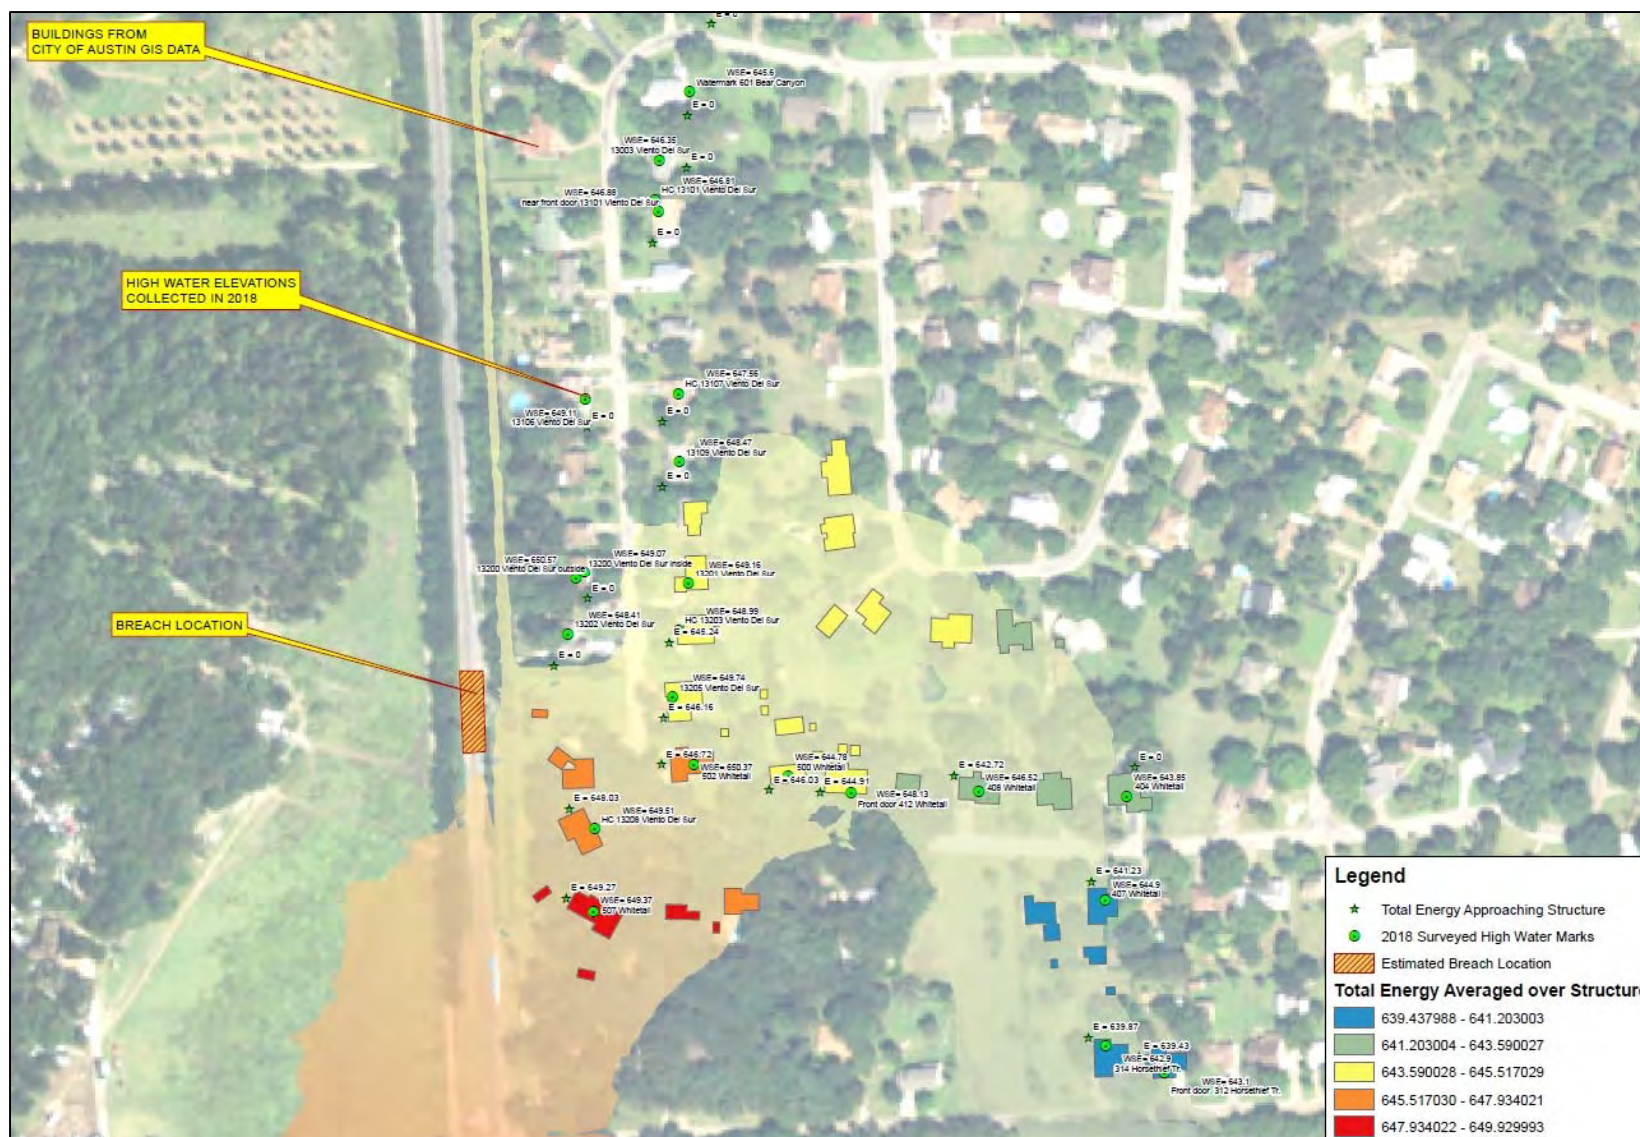
Figure 17 - WSE and Energy Estimates from the 2D Unsteady no-track Model, which assumes the UPRR embankment does not exist

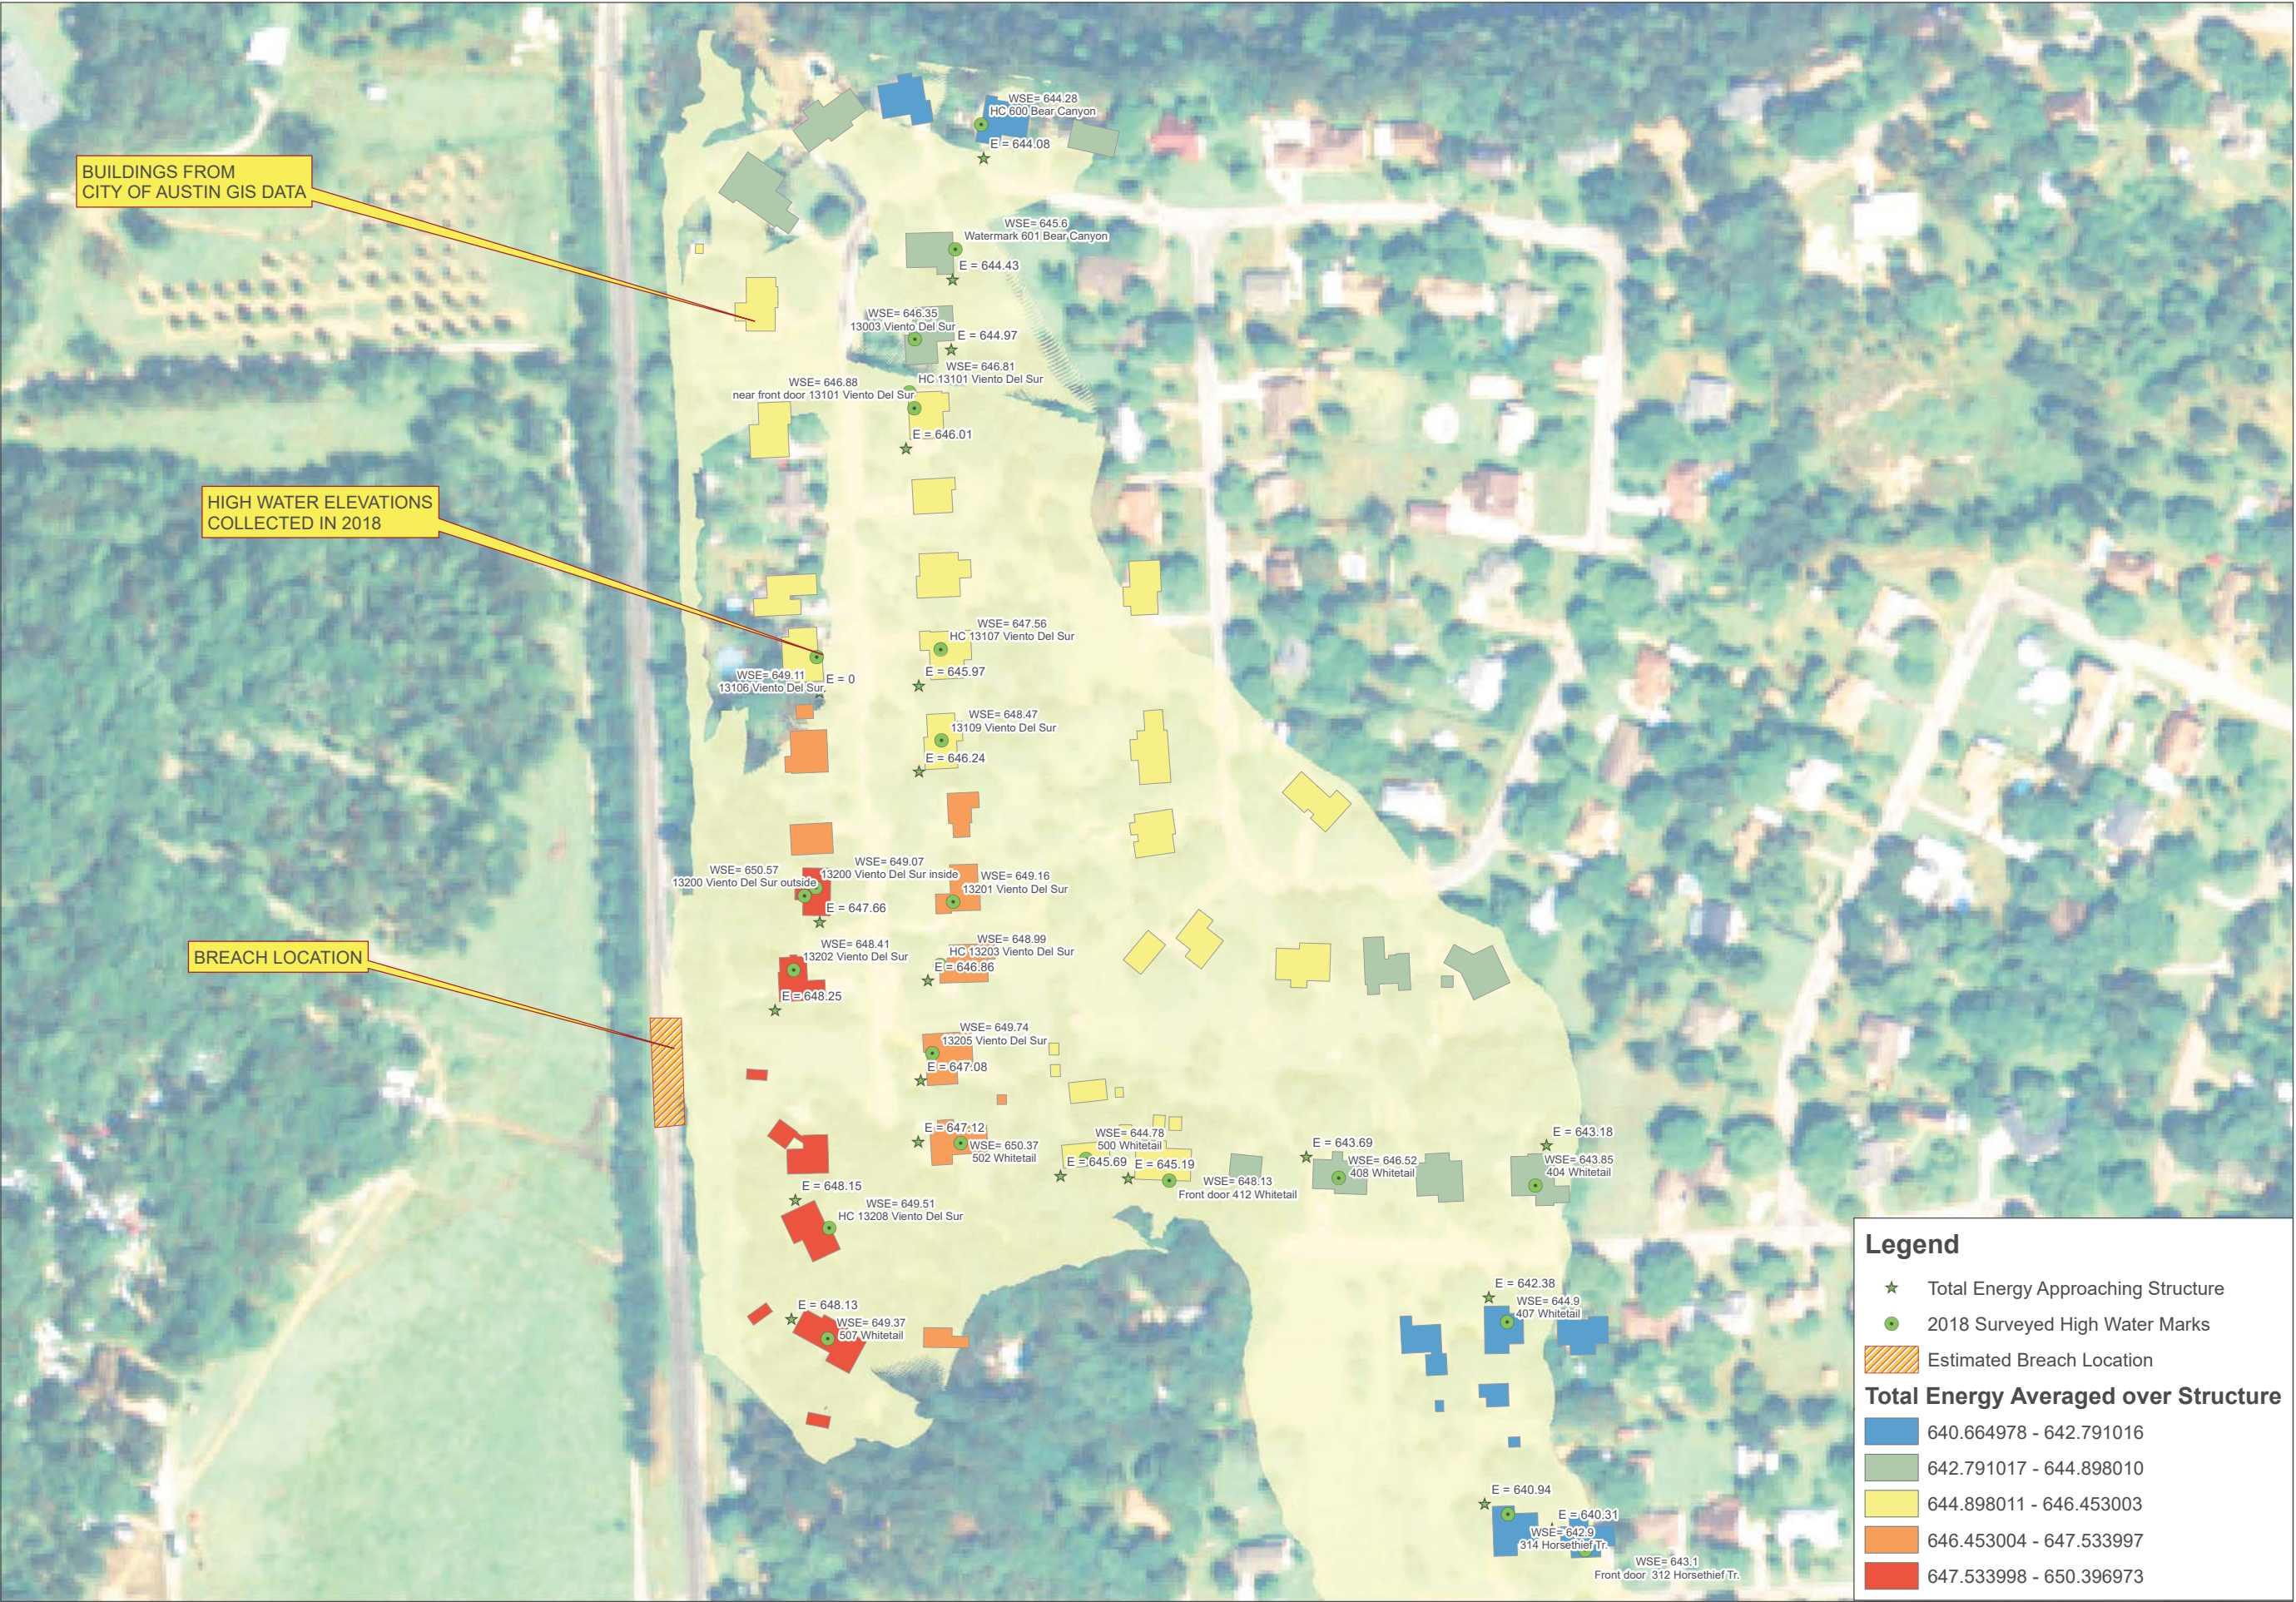
SHEET NUMBER:
3 OF 7
ORIGINAL SCALE:
1 inch = 100 feet

ARROYO DOBLE NEIGHBORHOOD
MAP SHOWING MEASURED AND
COMPUTED WSE VALUES FOR
THE 24 HR UNSTEADY BREACH
ESTIMATE QP=4,637 CFS

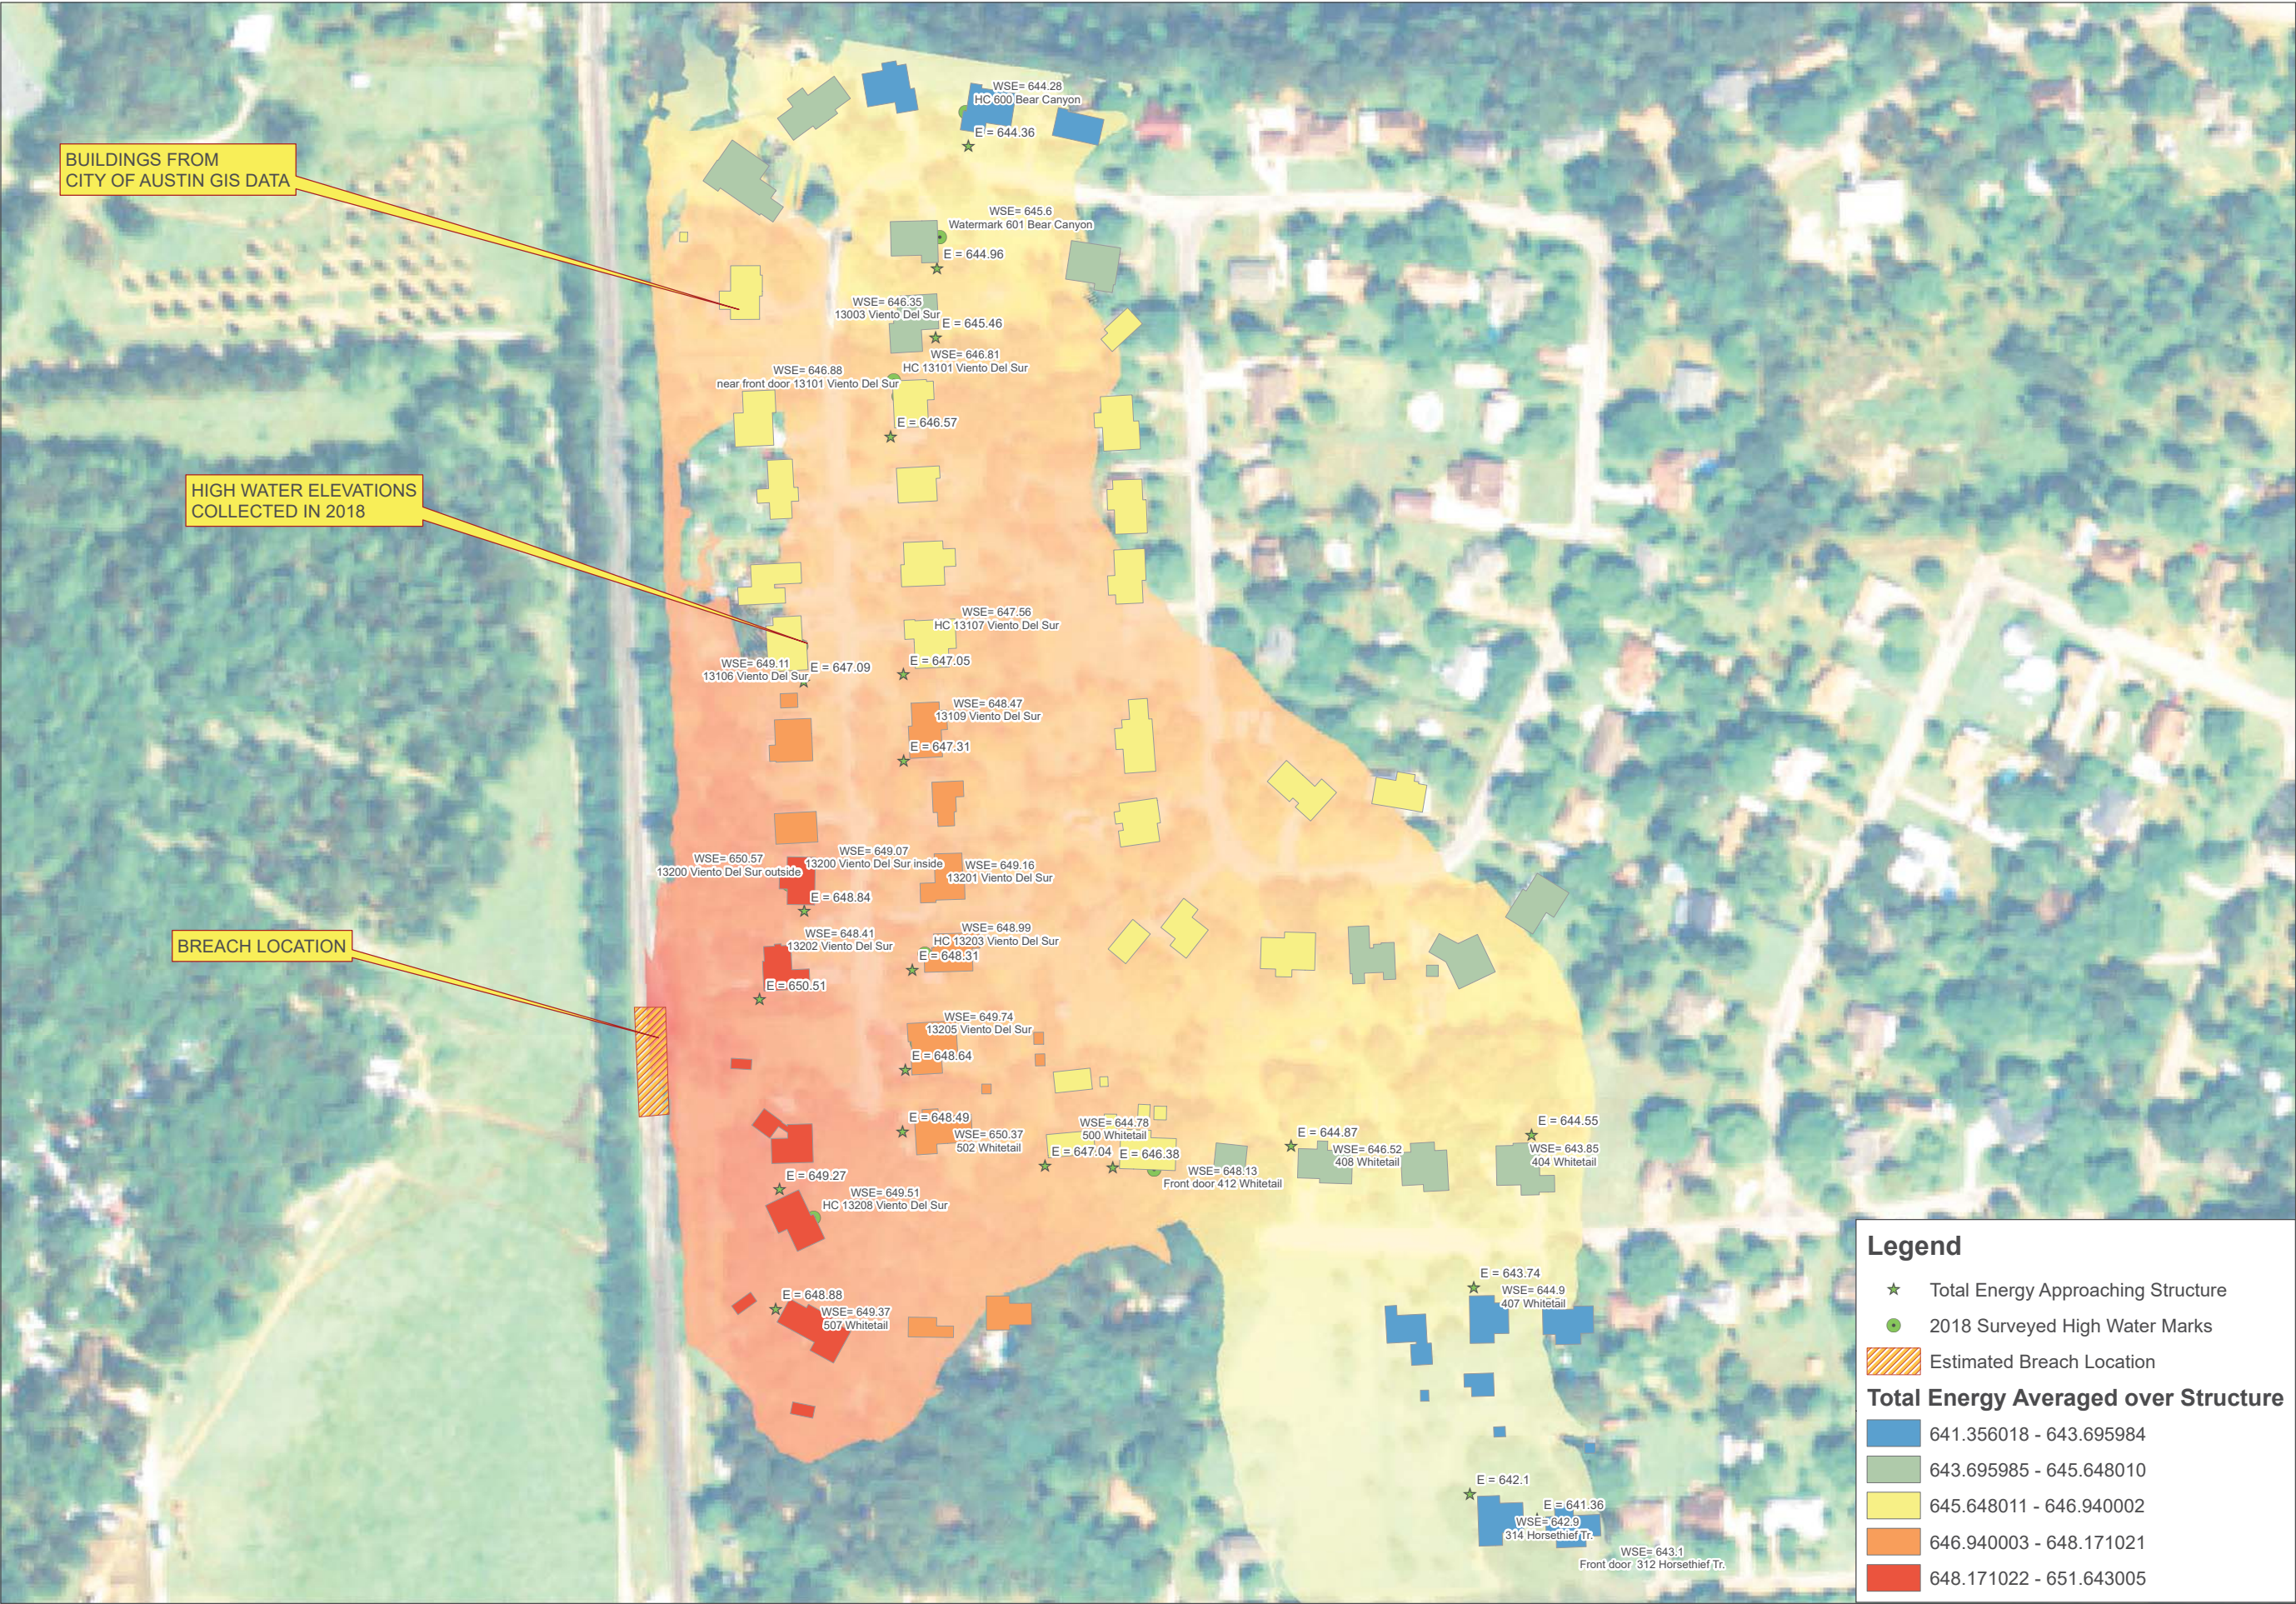
4 OF 7

**ARROYO DOBLE NEIGHBORHOOD
MAP SHOWING MEASURED AND
COMPUTED WSE VALUES FOR
THE UNSTEADY 6 HR BREACH
ESTIMATE QP=7,169 CFS**
